SPICER LIFE SERIES™
SERVICE MANUAL
SECTION 2
3264-SPL
MARCH 1998

55, 70, 90, 100, 140, 170 & 250

SPICER LIFE SERIES™ FEATURES & BENEFITS

This manual encompasses inspection, lubrication, removal and installation procedures for Spicer Life Series™ 55, 70, 90, 100, 140, 170 and 250 driveshaft assemblies.

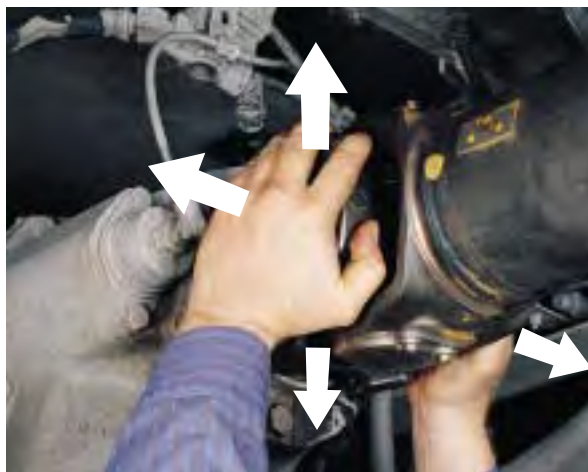
Photo 1

2. Check all input and output end fittings for looseness or broken back. Take hold of the end fitting with both hands. Try to move it vertically and horizontally to feel any looseness. (See photo 1, above.)

If looseness is evident, consult transmission, axle or transfer case original equipment manufacturers' service and maintenance manuals for proper end fitting specifications.

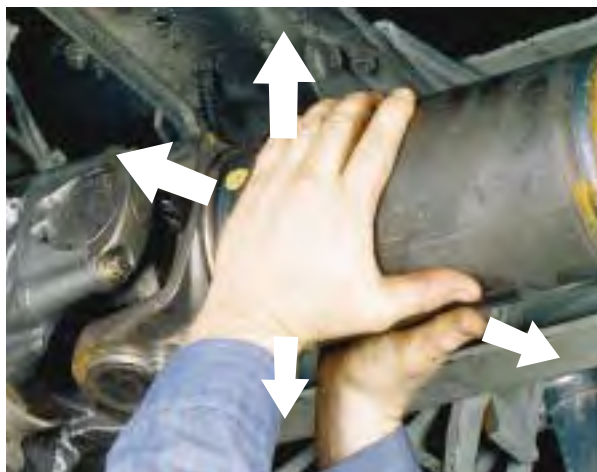
Photo 3

5. Check for excessive looseness across the ends of the universal joint bearing cup assemblies and trunnions. Take hold of the inboard yoke on the driveshaft with both hands. Try to move yoke vertically and horizontally. (See photo 3, above.)

There should be less than .006 in. (.15mm) movement in the universal joint kit relative to the inboard or outboard yokes. If looseness is greater than .006 in. (.15mm), the universal joint kit must be replaced. ⚠ See warning, below.

Excessive looseness across ends of universal joint bearing cup assemblies can cause imbalance or vibration in the driveshaft assembly. Imbalance or vibration can cause component wear, which can result in separation of the driveline from the vehicle. A separated driveline can result in property damage, serious personal injury or death.

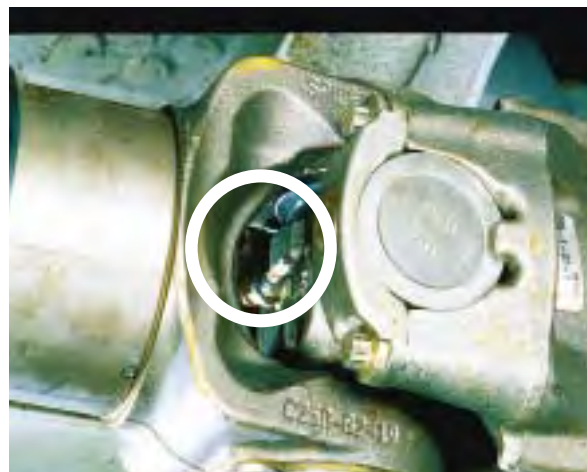
Photo 4, Relubable Style

7. Check for the presence of all grease zerk (nipple) fittings. (See photo 4, above). Grease zerk (nipple) fittings should not be missing, loose or fractured. ⚠ See warning, below.

If grease zerk (nipple) fitting is loose, tighten to required specifications. (See Table B, below.)

If grease zerk (nipple) fitting is fractured, replace grease zerk (nipple) fitting and tighten to required specifications. (See Table B, below.)

If grease zerk (nipple) fitting is missing, the entire universal joint kit needs to be replaced. Refer to the removal and installation sections of this manual for proper replacement procedures.

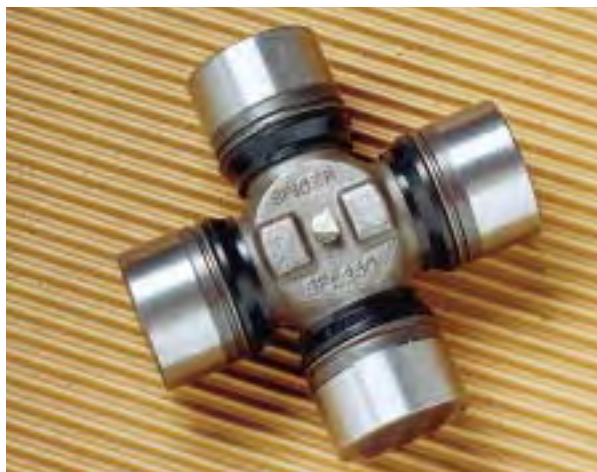
Photo 5, Permanently Lubricated Plug Style

8. Permanently lubricated plug style universal joint kits do not contain grease zerk (nipple) fittings, only a plug. (See photo 5, above.) Make sure plug is not missing, loose or fractured.

If the plug is loose, tighten to required specifications. (See Table B, step 7.) ▲ See warning, below.

If a plug is missing or fractured, the entire universal joint kit needs to be replaced. Refer to the removal and installation sections of this manual for proper replacement procedures.

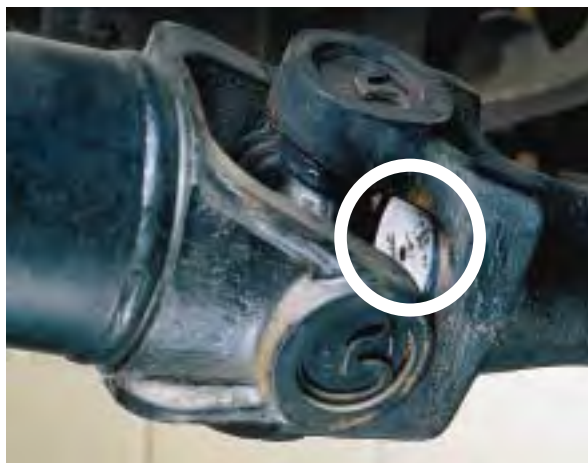
Photo 8

11. For an inboard and outboard slip yoke assembly design, check to be sure the slip yoke welch plug is not loose, missing or damaged. (See photo 8, above.) ▲ See warning, below.

If any of these situations are evident, replacement of the slip yoke and professional rebalancing of the driveshaft is necessary. Refer to the removal and installation sections of this manual for proper replacement procedures for slip members.

A loose, missing or damaged welch plug allows contaminants to invade the slip member assembly. Invasion of contaminants into the slip member assembly can degrade the lubricant and cause slip member component damage, which can result in separation of the driveline from the vehicle. A separated driveline can result in property damage, serious personal injury or death.

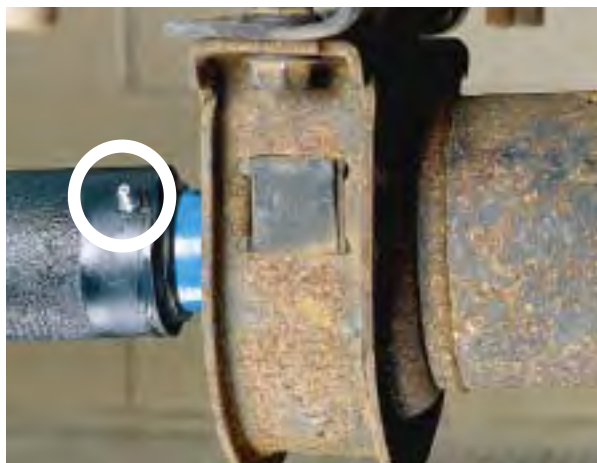
Photo 9

12. Visually inspect for the presence of the grease zerk (nipple) fitting, if applicable, on the slip yoke. (See photo 9, above.) Grease zerk (nipple) fittings should not be missing, loose or fractured. ⚠ See warning, below.

If grease zerk (nipple) fitting is loose, tighten to required specifications. (See Table C, below.)

If grease zerk (nipple) fitting is missing or fractured, the slip members may need to be replaced. Be sure to follow step 10 for inspection of radial looseness in slip member assembly.

If slip member assembly is within acceptable limits as stated in step 10, (page 14) install new grease zerk (nipple) fitting and tighten to required specifications. (See Table C, below). Be sure to completely relubricate slip member assembly with recommended lubricant. See lubrication section of this manual for proper procedures.

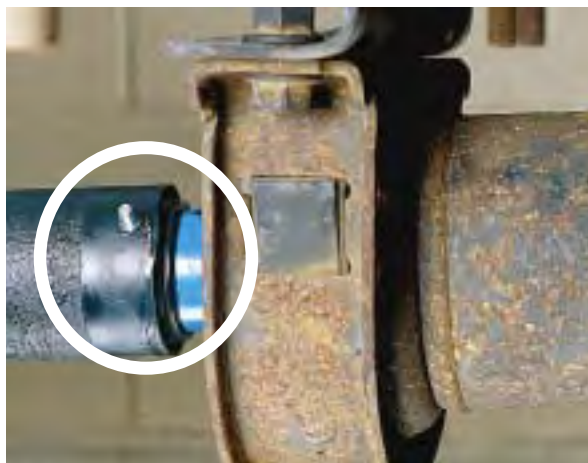
Photo 10

13. Check the slip yoke seal. (See photo 10, above.) Make sure the seal is properly attached to the slip yoke and is not loose or damaged. ⚠ See warning, below.

If any of these situations are evident, replacement of slip member assembly is necessary. Refer to the removal and installation sections of this manual for proper replacement procedures for slip members.

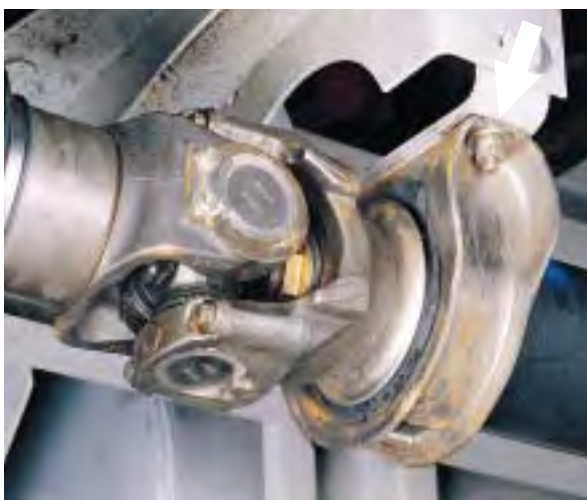
Photo 13

18. Inspect the center bearing bracket bolts for looseness. (See photo 13, below.) ▲ See warning, below.

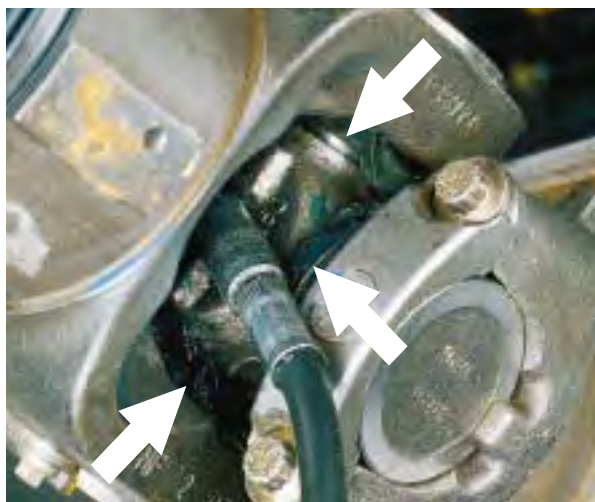
Photo 14

Make sure **fresh** grease is evident at all universal joint bearing seals. (See photo 14, below.)

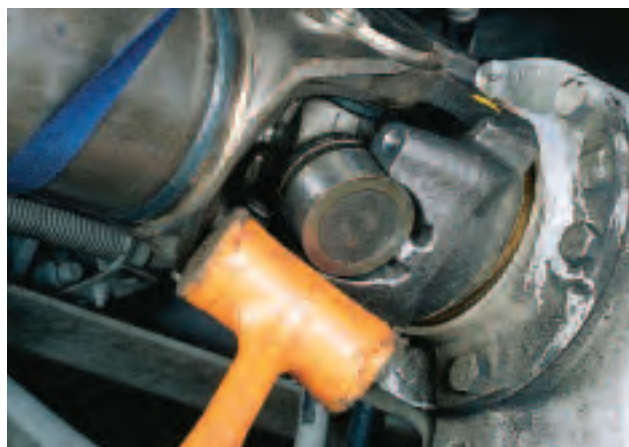
Photo 55

4. It may be necessary to unseat bearing cup assemblies, pilot or serrated connection by tapping on tube yoke or bearing cup with a soft-faced hammer. (See photo 55, below.) Once the bearing cup assemblies or connections are free, collapse the driveshaft until both bearing cup assemblies clear the open cross holes or flange yoke pilot is disconnected. Allow the driveshaft to rest on support strap.

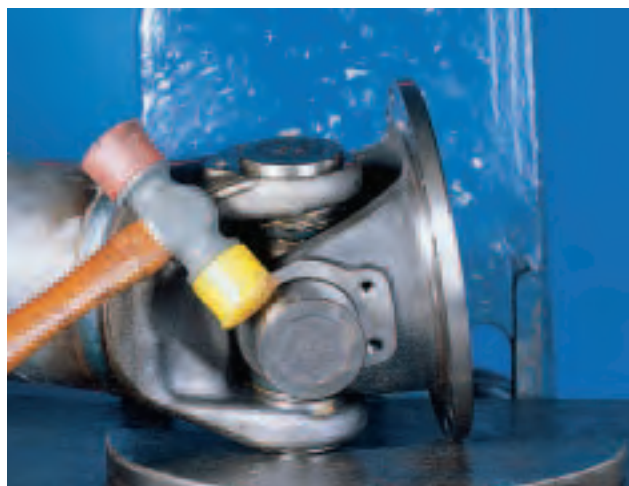
Photo 59, Companion Flange Style

17. Bearing cup is not designed to drop out of flange yoke. It will be necessary to use a soft-faced hammer to tap the partially pressed-out bearing cup from side to side, to “walk” the bearing cup out of flange yoke ear. (See photo 59, top right.)

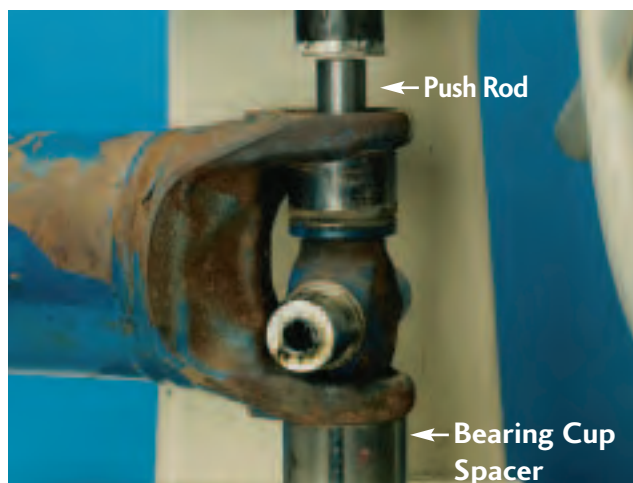
Photo 63

Using an arbor press, press down on the upper bearing cup assembly until the shoulder of the journal cross makes contact with the inside of the yoke ear. (See photo 63, below.)

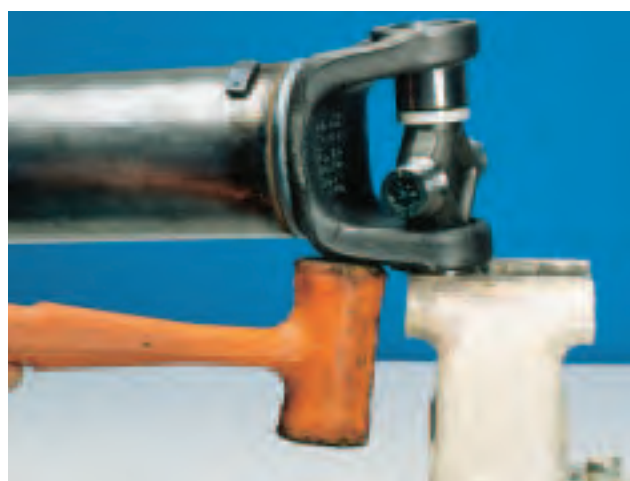
Photo 74

23. Grip the bearing cup in bench vice. (See photo 74, below.) Strike the yoke ear with a soft-faced hammer until bearing is removed.

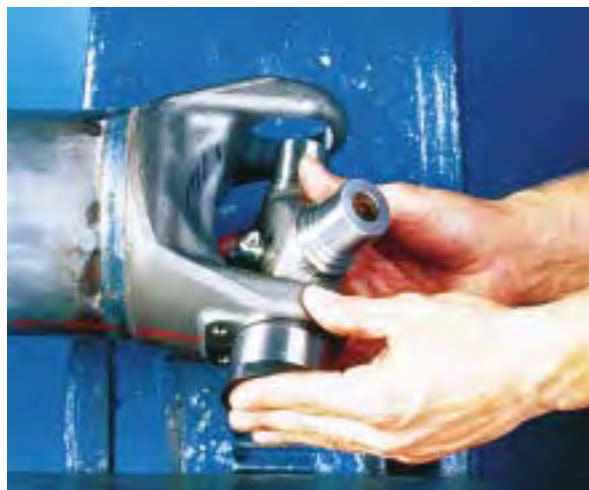
Photo 114

3. Move one end of the journal cross to cause a trunnion to project through the cross hole beyond the outer machined face of the yoke ear. Take one bearing cup assembly and position an installation height tool on the end of a bearing cup. Place the bearing cup assembly over the protruding trunnion diameter and align it to yoke cross hole. (See photo 114, top right.)
